U.S.-Canada Power System Outage Task Force

**Final Report on the
August 14, 2003 Blackout
in the
United States and Canada:**

**Causes and
Recommendations**

April 2004

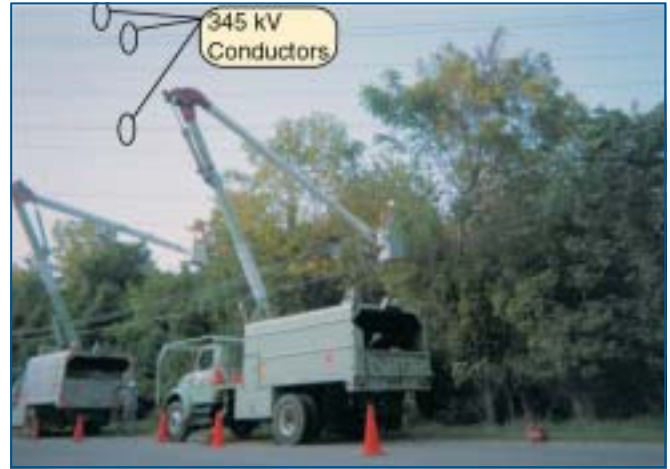
This August 14 photo shows the tree that caused the loss of the Hanna-Juniper line (tallest tree in photo). Other 345-kV conductors and shield wires can be seen in the background. Photo by Nelson Tree.
