U.S.-Canada Power System Outage Task Force

**Final Report on the
August 14, 2003 Blackout
in the
United States and Canada:**

**Causes and
Recommendations**

April 2004

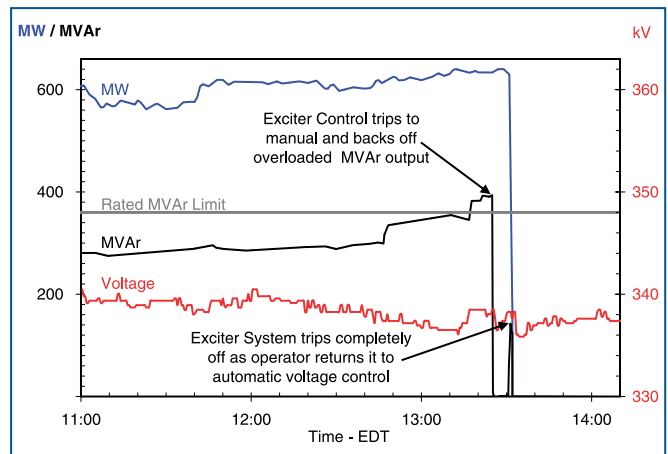
Figure 4.3. MW and MVar Output from Eastlake Unit 5 on August 14

- ◆ Eastlake Unit 5 is a 597 MW (net) generating unit located west of Cleveland on Lake Erie. It is a major source of reactive power support for the Cleveland area. It tripped at 13:31 EDT. The cause of the trip was that as the Eastlake 5 operator sought to increase the unit's reactive power output (Figure 4.3), the unit's protection system detected that VAR output exceeded the unit's VAR capability and tripped the unit off-line. The loss of the Eastlake 5 unit did not put the grid into an unreliable state—i.e., it was still able to withstand safely another contingency. However, the loss of the unit required FE to import additional power to make up for the loss of the unit's output (612 MW), made voltage management in northern Ohio more challenging, and gave FE operators less flexibility in operating their system (see details on pages 45-46 and 49-50).

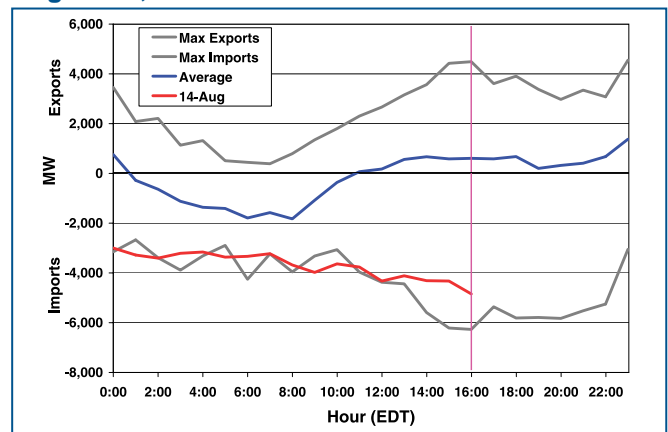
Figure 4.5. Scheduled Imports and Exports for the Northeast Central Region, June 1 through August 13, 2003

Figure 4.5 shows total scheduled imports for the entire northeast region for June through August 14, 2003. These transfers were well within the range of previous levels, as shown in Figure 4.5, and well within all established limits. In particular, on August 14 increasing amounts of the growing imports into the area were being delivered to FirstEnergy's Ohio territory to meet its increasing demand and to replace the generation lost with the trip of Eastlake 5. The level of imports into Ontario from the U.S. on August 14 was high (e.g., 1,334 MW at 16:00 EDT through the New York and Michigan ties) but not unusual, and well within IMO's import capability. Ontario is a frequent importer and exporter of power, and had imported similar and higher amounts of power several times during the summers of 2002 and 2003. PJM and Michigan also routinely import and export power across ECAR.

Some have suggested that the level of power flows into and across the Midwest was a direct cause of the blackout on August 14. Investigation team modeling proves that these flows were neither a cause nor a contributing factor to the blackout. The team used detailed modeling and simulation incorporating the NERC TagNet data on actual

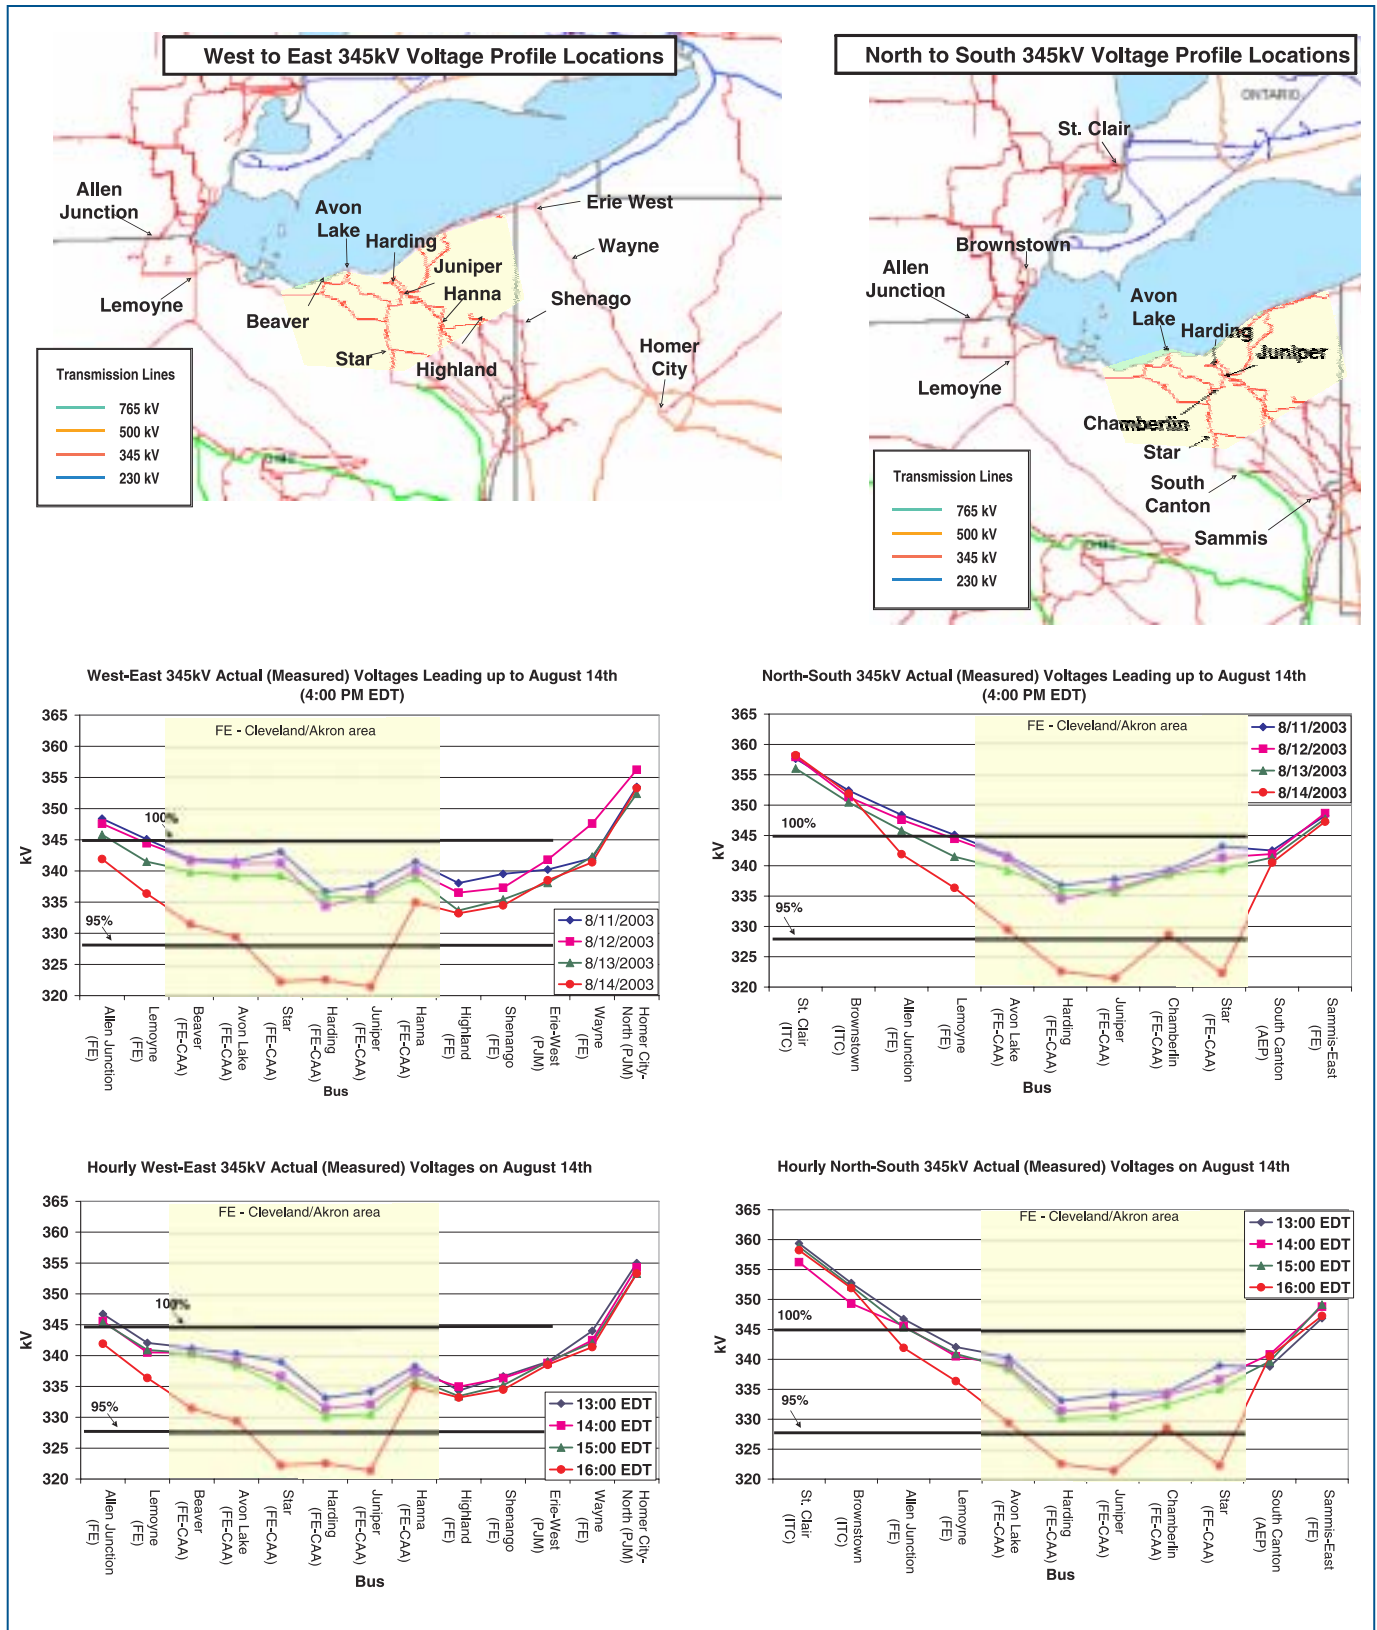
Figure 4.7. Actual Voltages Across the Ohio Area Before and On August 14, 2003

Figure 4.7 shows the profile of voltage levels at key buses from southeast Michigan across Ohio into western Pennsylvania from August 11 through 14 and for several hours on August 14. These transects show that across the area, voltage levels were consistently lower at the 345-kV buses in the Cleveland-Akron area (from Beaver to Hanna on the west to east plot and from Avon Lake to Star on the north to south plot) for the three days and the 13:00 to 15:00 EDT period preceding the blackout. Voltage was consistently and considerably higher at the outer ends of each transect, where it never dropped below 96% even on August 14. These profiles also show clearly the decline of voltage over the afternoon of August 14, with voltage at the Harding bus at 15:00 EDT just below 96% before the Harding-Chamberlin line tripped at 15:05 EDT, and dropping down to around 93% at 16:00 EDT after the loss of lines and load in the immediate area.

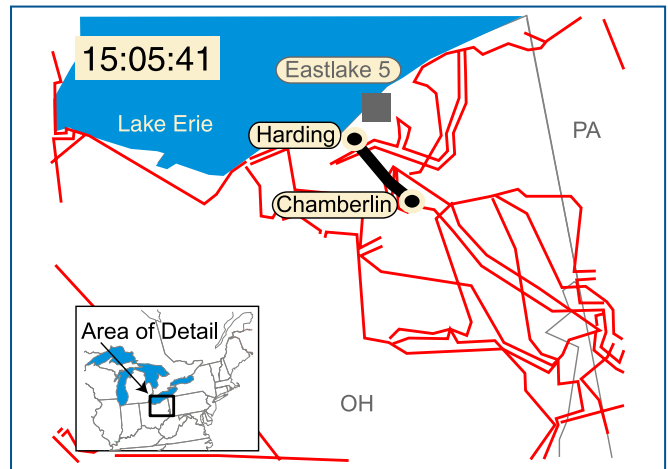
Figure 5.8. Harding-Chamberlin 345-kV Line

A short-circuit occurred on the Harding-Chamberlin 345-kV line due to a contact between the line conductor and a tree. This line failed with power flow at only 44% of its normal and emergency line rating. Incremental line current and temperature increases, escalated by the loss of Harding-Chamberlin, caused more sag on the Hanna-Juniper line, which contacted a tree and failed with power flow at 88% of its normal and emergency line rating. Star-South Canton

At 15:05:41 EDT, FE's Harding-Chamberlin line (Figure 5.8) tripped and locked out while loaded at 44% of its normal and emergency rating. At this low loading, the line temperature would not exceed safe levels—even if still air meant there

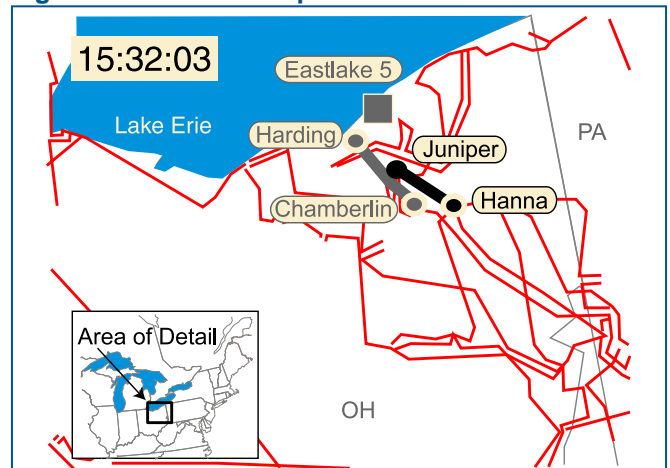
Figure 5.9. Hanna-Juniper 345-kV Line

At 15:32:03 EDT the Hanna-Juniper line (Figure 5.9) tripped and locked out. A tree-trimming crew was working nearby and observed the tree/line contact. The tree contact occurred on the south phase, which is lower than the center phase due to construction design. Although little evidence remained of the tree during the field team’s visit in October, the team observed a tree stump 14 inches (35.5 cm) in diameter at its ground line and talked to an individual who witnessed the contact on August 14.²⁶ Photographs clearly indicate that the tree was of excessive height (Figure 5.10). Surrounding trees were 18 inches (45.7 cm) in diameter at ground line and 60 feet (18.3 meters) in

Hanna-Juniper was loaded at 88% of its normal and emergency rating when it tripped. With this line open, over 1,200 MVA of power flow had to find a new path to reach its load in Cleveland. Loading on the remaining two 345-kV lines increased, with Star-Juniper taking the bulk of the power. This caused Star-South Canton's loading to rise above its normal but within its emergency rating and pushed more power onto the 138-kV system. Flows west into Michigan decreased slightly and voltages declined somewhat in the Cleveland area.

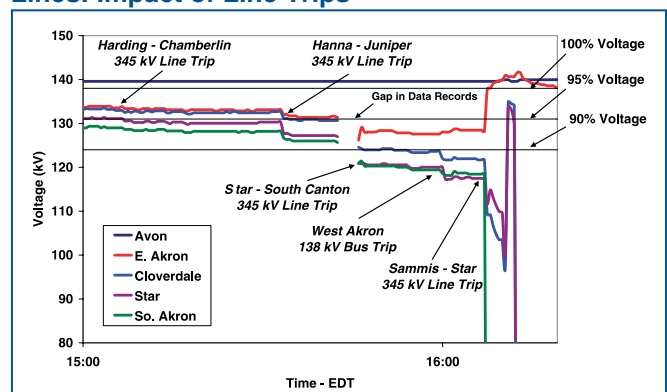
Figure 5.14. Voltages on FirstEnergy’s 138-kV Lines: Impact of Line Trips

Figure 5.14 shows how actual voltages declined at key 138-kV buses as the 345- and 138-kV lines were lost. As these lines failed, the voltage drops caused a number of large industrial customers with voltage-sensitive equipment to go off-line automatically to protect their operations. As the 138-kV lines opened, they blacked out customers in Akron and the areas west and south of the city, ultimately dropping about 600 MW of load.

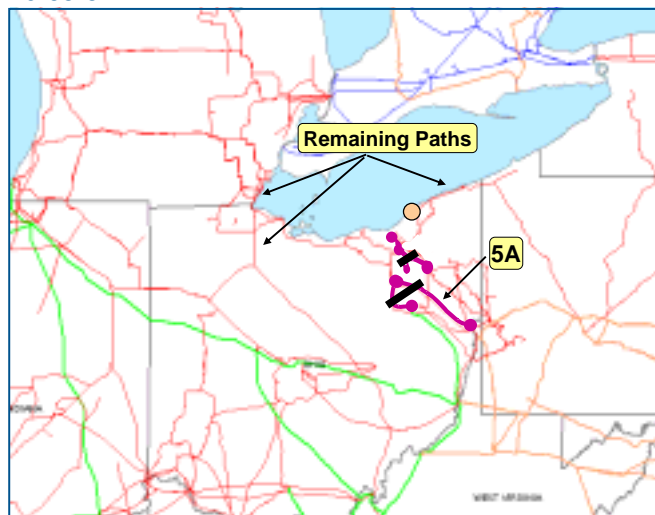
Figure 6.3. Sammis-Star 345-kV Line Trip, 16:05:57 EDT

After the loss of FE's Sammis-Star 345-kV line and the underlying 138-kV system, there were no large capacity transmission lines left from the south to support the significant amount of load in northern Ohio (Figure 6.3). This overloaded the

The Sammis-Star 345-kV line trip completely severed the 345-kV path into northern Ohio from southeast Ohio, triggering a new, fast-paced sequence of 345-kV transmission line trips in which each line trip placed a greater flow burden on those lines remaining in service. These line outages left only three paths for power to flow into western Ohio: (1) from northwest Pennsylvania to northern Ohio around the south shore of Lake Erie, (2) from southwest Ohio toward northeast Ohio, and (3) from eastern Michigan and Ontario. The line interruptions substantially weakened northeast Ohio as a source of power to eastern Michigan, making the Detroit area more reliant on 345-kV lines west and northwest of Detroit, and from northwestern Ohio to eastern Michigan. The impact of this trip was felt across the grid—it caused a 100 MW increase in flow from PJM into New York and through to Ontario.¹ Frequency in the Eastern Interconnection increased momentarily by 0.02 Hz.

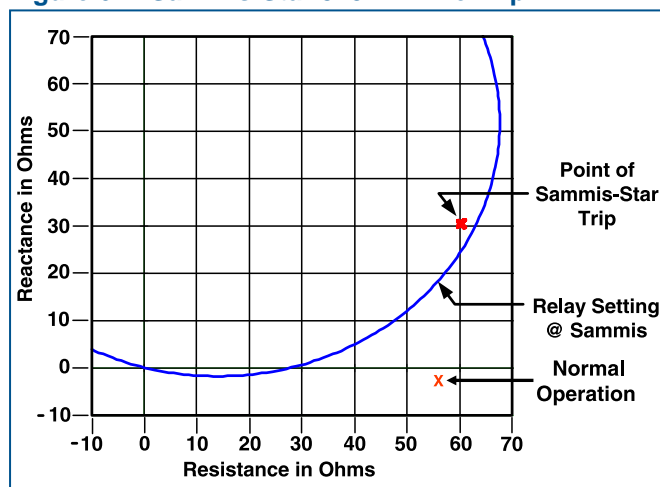
Figure 6.4. Sammis-Star 345-kV Line Trip

Sammis-Star did not trip due to a short circuit to ground (as did the prior 345-kV lines that tripped). Sammis-Star tripped due to protective zone 3 relay action that measured low apparent impedance (depressed voltage divided by abnormally high line current) (Figure 6.4). There was no fault and no major power swing at the time of the trip—rather, high flows above the line's emergency rating together with depressed voltages caused the overload to appear to the protective relays as a remote fault on the system. In effect, the relay could no longer differentiate between a remote three-phase fault and an exceptionally high line-load condition. Moreover, the reactive flows (VAr) on the line were almost ten times higher than they had been earlier in the day because of the current overload. The relay operated as it was designed to do.

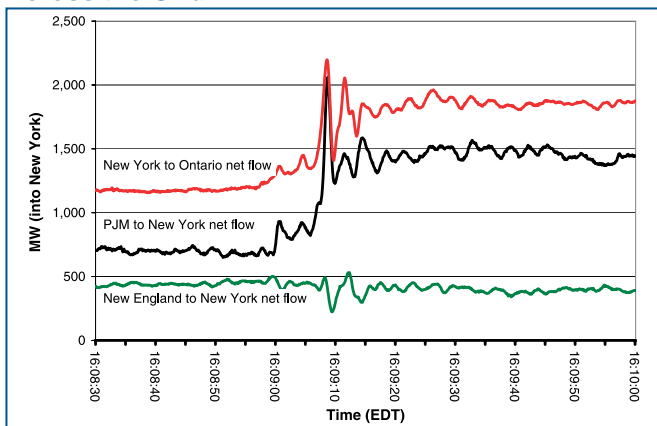
Figure 6.8. First Power Swing Has Varying Impacts Across the Grid

Figure 6.8, of metered power flows along the New York interfaces, documents how the flows heading north and west toward Detroit and Cleveland varied at different points on the grid. Beginning at 16:09:05 EDT, power flows jumped simultaneously across all three interfaces—but when the first power surge peaked at 16:09:09, the change in flow was highest on the PJM interface and lowest on the New England interface. Power flows increased significantly on the PJM-NY and NY-Ontario interfaces because of the redistribution of flow around Lake Erie. The New England and Maritime systems maintained the same generation to load balance and did not carry the redistributed flows because they were not in the direct path of the flows, so that interface with New York showed little response.

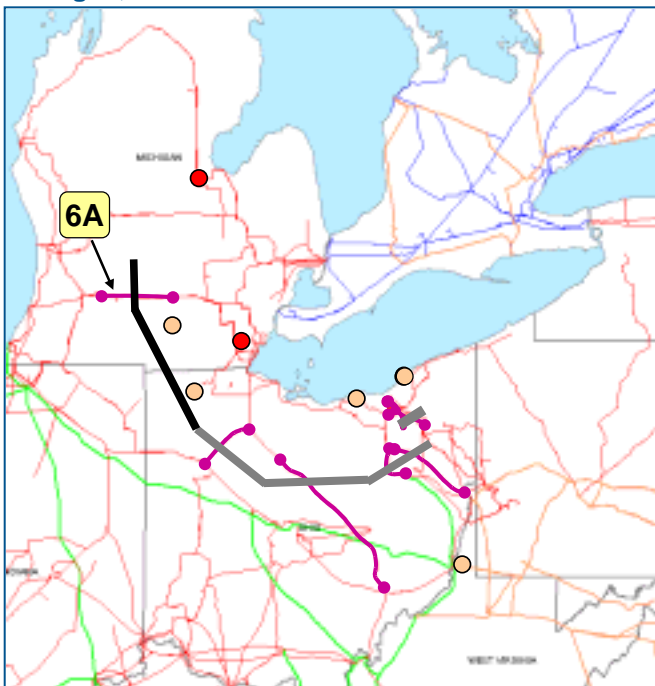
Figure 6.11. Transmission and Generation Trips in Michigan, 16:10:36 to 16:10:37 EDT

under-voltage on the system. Michigan lines west of Detroit then began to trip, as shown in Figure 6.11.

The Argenta-Battle Creek relay first opened the line at 16:10:36.230 EDT, reclosed it at 16:10:37, then tripped again. This line connects major generators—including the Cook and Palisades nuclear plants and the Campbell fossil plant—to the MECS system. This line is designed with auto-reclose breakers at each end of the line, which do an automatic high-speed reclose as soon as they open to restore the line to service with no interruptions. Since the majority of faults on the North American grid are temporary, automatic reclosing can enhance stability and system reliability. However, situations can occur when the power systems behind the two ends of the line could go out of phase during the high-speed reclose period (typically less than 30 cycles, or one half second, to allow the air to de-ionize after the trip to prevent arc re-ignition). To address this and protect generators from the harm that an out-of-synchronism reconnect could cause, it is worth studying whether a synchro-check relay is needed, to reclose the second breaker only when the two ends are within a certain voltage and phase angle tolerance. No such protection was installed at Argenta-Battle Creek; when the line reclosed, there was a 70° difference in phase across the circuit breaker reclosing the line. There

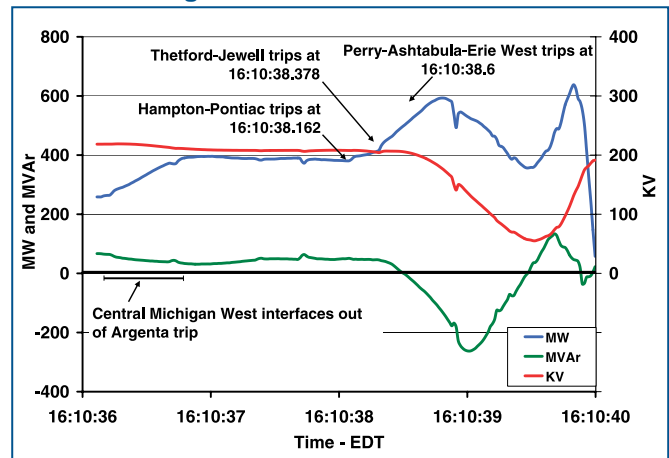
Figure 6.12. Flows on Keith-Waterman 230-kV Ontario-Michigan Tie Line

The Power System Disturbance Recorders at Keith and Lambton, Ontario, captured these events in the flows across the Ontario-Michigan interface, as shown in Figure 6.12 and Figure 6.16. It shows clearly that the west to east Michigan separation (the Thetford-Jewell trip) was the start and Erie West-Ashtabula-Perry was the trigger for the 3,700 MW surge from Ontario into Michigan. When Thetford-Jewell tripped, power that had been flowing into Michigan and Ohio from western Michigan, western Ohio and Indiana was cut off. The nearby Ontario recorders saw a pronounced impact as flows into Detroit readjusted to draw power from the northeast instead. To the south,

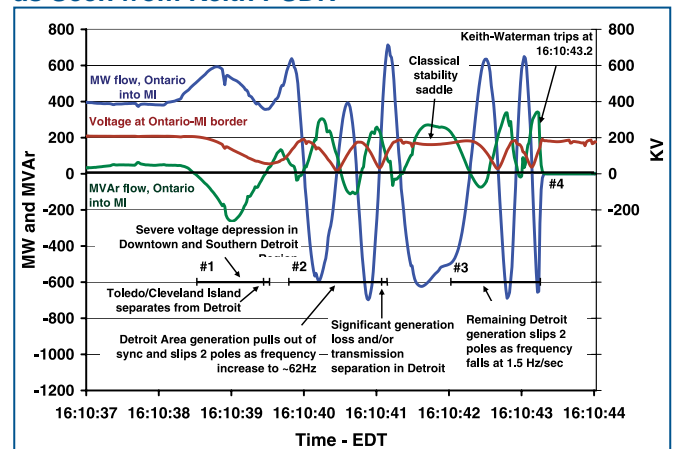
Figure 6.19. Generators Under Stress in Detroit, as Seen from Keith PSDR

The tremendous power flow into Michigan, beginning at 16:10:38, occurred when Toledo and Cleveland were still connected to the grid only through Detroit. After the Bay Shore-Monroe line tripped at 16:10:39, Toledo-Cleveland were separated into their own island, dropping a large amount of load off the Detroit system. This left Detroit suddenly with excess generation, much of which was greatly accelerated in angle as the depressed voltage in Detroit (caused by the high demand in Cleveland) caused the Detroit units to pull nearly out of step. With the Detroit generators

running at maximum mechanical output, they began to pull out of synchronous operation with the rest of the grid. When voltage in Detroit returned to near-normal, the generators could not fully pull back its rate of revolutions, and ended up producing excessive temporary output levels, still out of step with the system. This is evident in Figure 6.19, which shows at least two sets of generator “pole slips” by plants in the Detroit area between 16:10:40 EDT and 16:10:42 EDT. Several large units around Detroit—Belle River, St. Clair, Greenwood, Monroe, and Fermi—all tripped in response. After formation of the Cleveland-Toledo island at 16:10:40 EDT, Detroit frequency spiked to almost 61.7 Hz before dropping, momentarily equalized between the Detroit and Ontario systems, but Detroit frequency began to decay at 2 Hz/sec and the generators then experienced under-speed conditions.

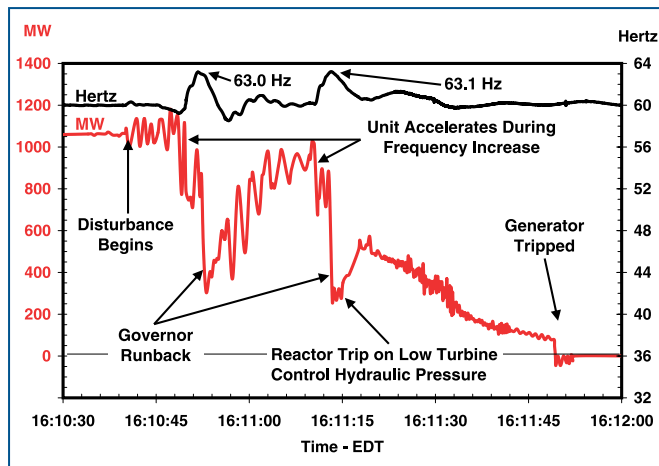
Figure 6.25. Events at One Large Generator During the Cascade

it back again as some frequencies changed several times by as much as 3 Hz (about 100 times normal deviations). Figure 6.25 is a plot of the MW output and frequency for one large unit that nearly survived the disruption but tripped when in-plant hydraulic control pressure limits were eventually violated. After the plant control system called for shutdown, the turbine control valves closed and the generator electrical output ramped down to a preset value before the field excitation tripped and the generator breakers opened to disconnect the unit from the system. This also illustrates the time lag between system events and the generator reaction—this generator was first disturbed by system conditions at 16:10:37, but did not trip until 16:11:47, over a minute later.
